# Manhole Inspection Summary

Manhole # S21C1\_026MH

Insp Date: **5/21/08 3:00 PM**

**Location** Address: **2627 paca-ridgely alley** Cross Street: **atlantic-harman alley**

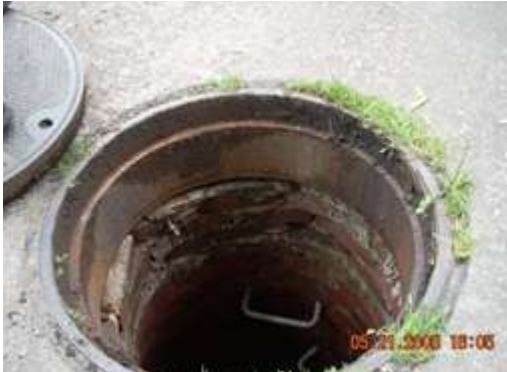
defect 2

**Frame** Offset: **1.5** (in.) Condition: ☐ Sound ☐ Cracked ☒ **Leaks**

frame leaks-inflow evidence from ponding

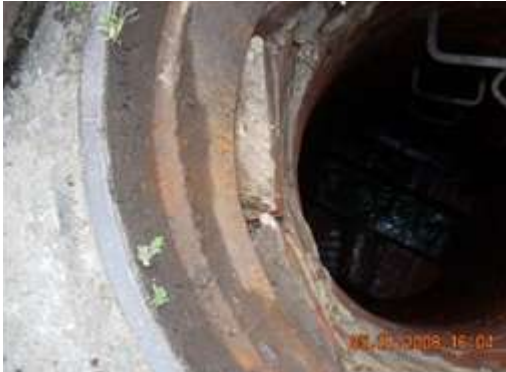
Defect 1

frame offset

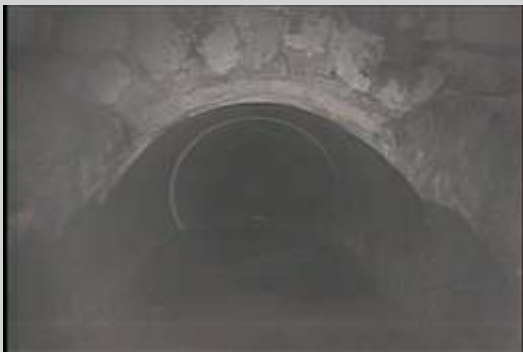
12 O'Clock Outflow

15 in. Circular Gravity Sewer  
Pipe Out @ 12 O'Clock

Pipe Height: **15.6** (in.) Rod and Bar (Angled)  
Pipe Material: **Clay** ☐ Pipe Lined  
Invert Depth: **13.32** (ft.) Flow Characteristics: **Slow**  
Deposits: ☒ None ☐ Mud ☐ Sludge ☐ Debris ☐ Grease  
Silt Depth: **0** (in.) Deposits Extent:  
Infiltration: **None** Pipe Seal Cond: **Sound**

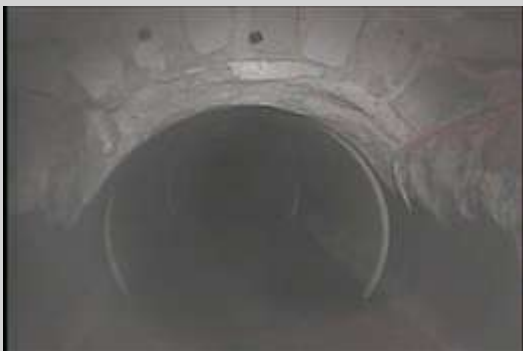
6 O'Clock Inflow

15 in. Circular Gravity Sewer  
Pipe In @ 6 O'Clock

Pipe Height: **15.6** (in.) Rod and Bar (Angled)  
Pipe Material: **Clay** ☐ Pipe Lined  
Invert Depth: **13.31** (ft.) Flow Characteristics: **Slow**  
Deposits: ☒ None ☐ Mud ☐ Sludge ☐ Debris ☐ Grease  
Silt Depth: **0** (in.) Deposits Extent:  
Infiltration: **None** Pipe Seal Cond: **Sound**

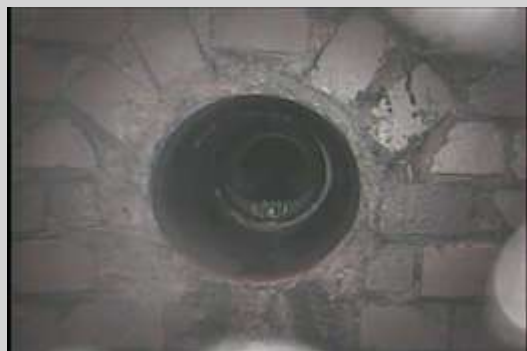
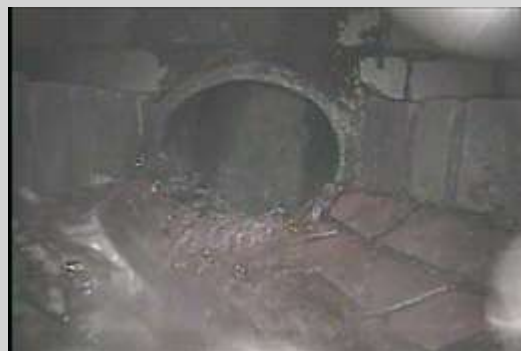
9 O'Clock Inflow

8 in. Circular Gravity Sewer

Pipe In @ 9 O'Clock

Drop In @ 9 O'Clock

Drop: **Outside** Rod and Bar

Drop Condition: **Open**
